Addendum No. 1 Bid No.070523-Demolition Project for Madera USD

Re: Asbestos Survey
Demo House
13544 Road 26 ½
Madera, CA
Job No. S75-23-01

Asbestos Survey: Demo House, 13544 Road 26 ½, Madera, CA **S75-23-01**

Re: Asbestos Survey
Demo House & Garage/Shop
13568 Road 26 ½
Madera, CA
Job No. S75-23-02

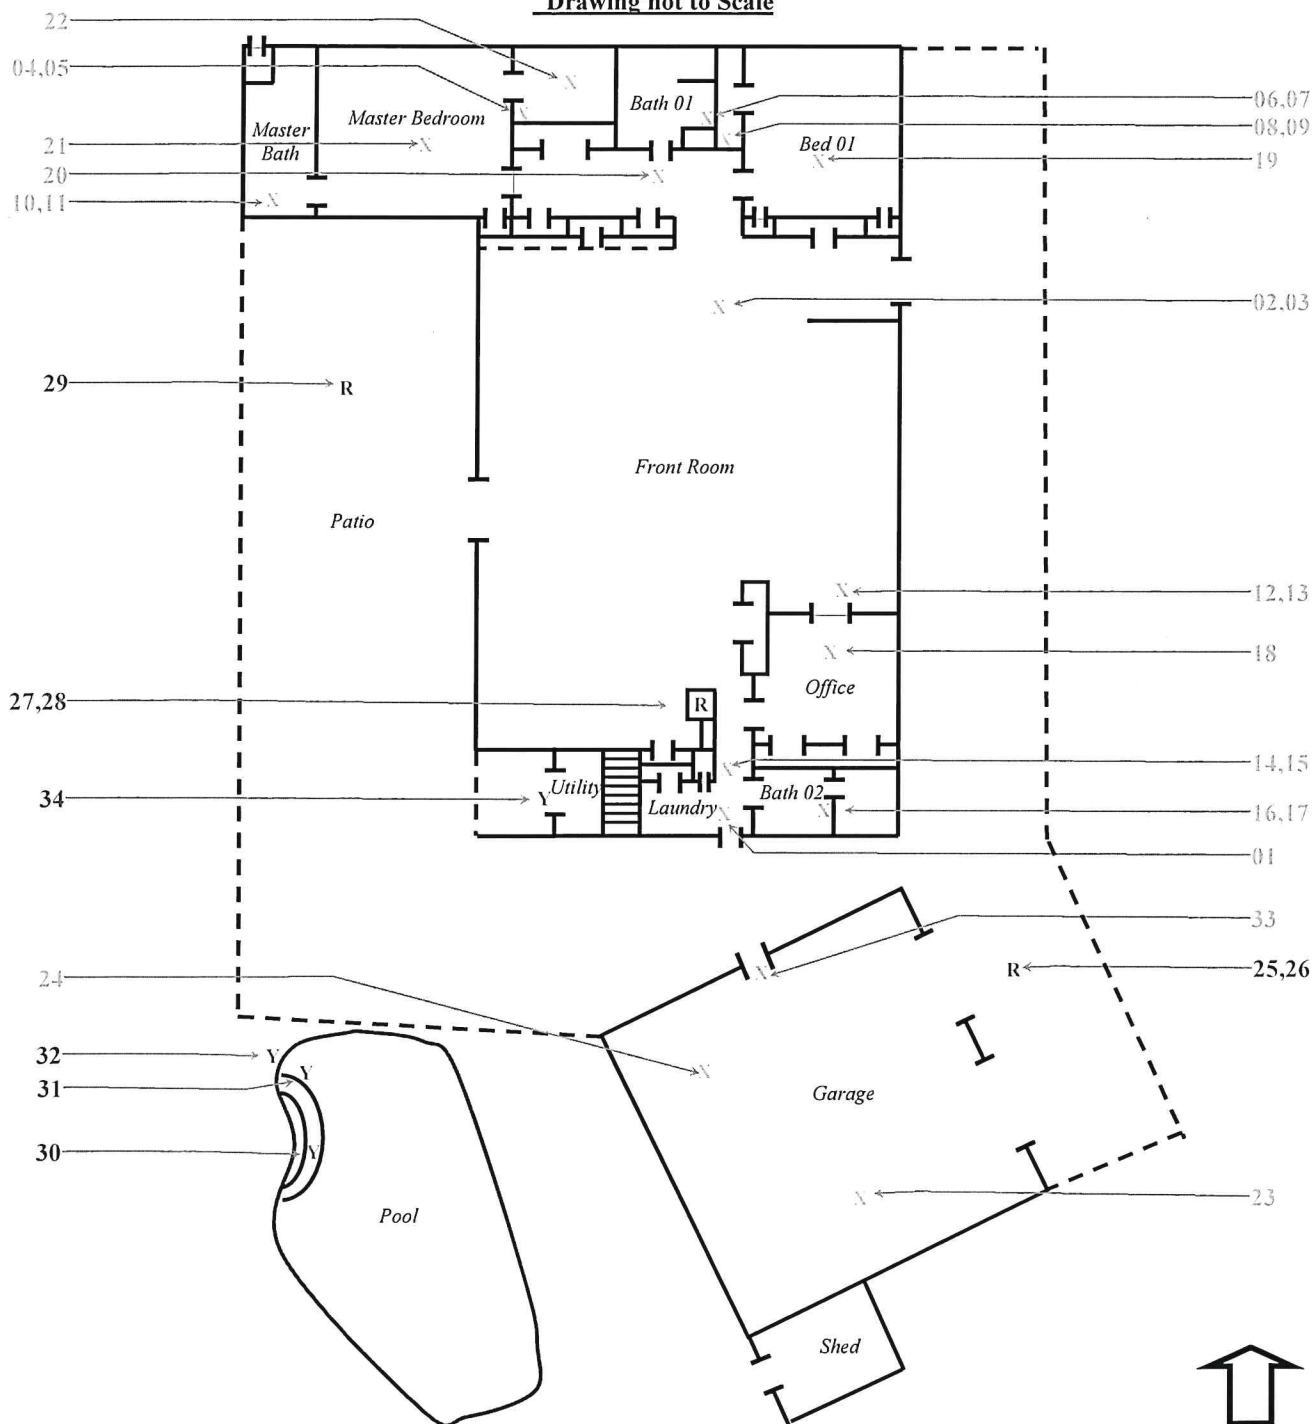
Job S75-23 / Sample Location Diagram
Demo House / 13544 Road 26 ½, Madera, CA
Domingo Mora / Madera Unified School District
Drawing not to Scale

The Linoleum and Adhesive (sample 01) located on the floor in the laundry room, bathroom, and hall, is positive for asbestos at 5%.

These materials are considered ***friable hazardous ACM*** and it is required that a licensed asbestos abatement contractor remove these materials prior to renovation and or demolition of this structure.

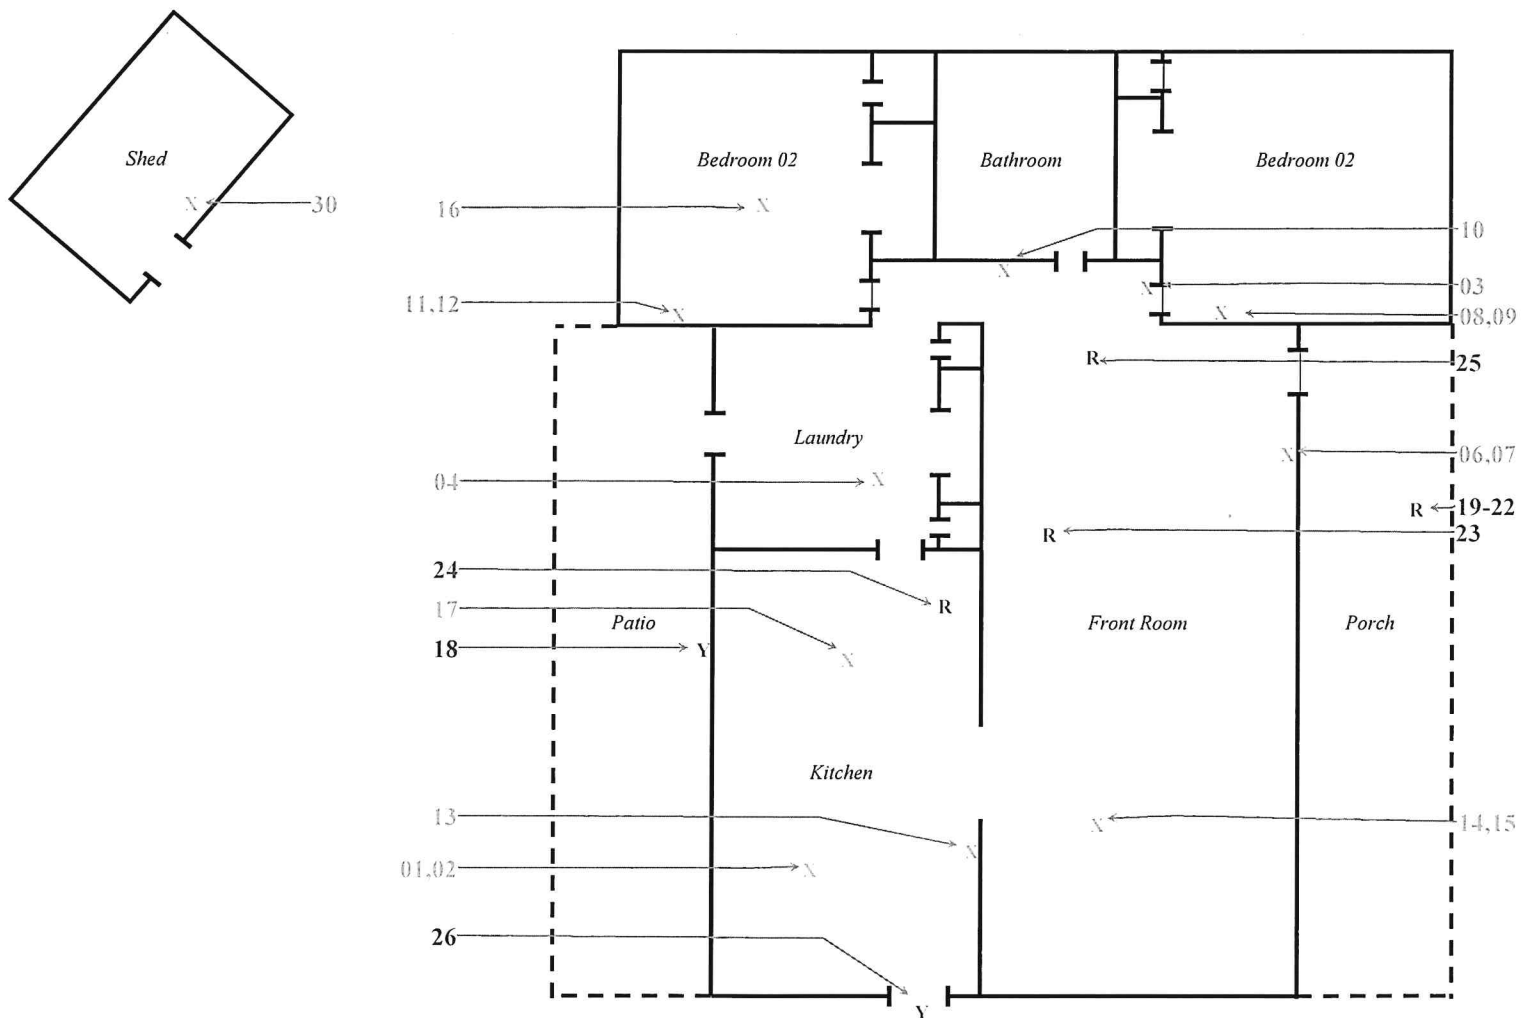
Job S75-23-02 Sample Location Diagram
Demo House / 13568 Road 26 ½, Madera, CA
Domingo Mora / Madera Unified School District
Drawing not to Scale

The Black Mastic (sample 02) located under the floor tile In the kitchen (bottom layer) is positive for asbestos at 3%.

The Linoleum and Adhesive (samples 01, 04) located on the floor in the kitchen (top layer) and laundry room (top layer) is positive for asbestos at 5%.

These materials are considered a ***non-hazardous non-friable ACM***. It is required that a licensed asbestos abatement contractor remove these materials prior to renovation and or demolition of this structure.

These materials are considered ***friable hazardous ACM*** and it is required that a licensed asbestos abatement contractor remove these materials prior to renovation and or demolition of this structure.
